PHASE I INSPECTION REPORT  
NATIONAL DAM INSPECTION PROGRAM

Hawstone Dam: NDI I.D. No. PA-00580

Owner: John Hostetter  
State Located: Pennsylvania (PennDER I.D. No. 44-7)  
County Located: Mifflin  
Stream: Unnamed Tributary to the Juniata River  
Inspection Date: 26 November 1979  
Inspection Team: GAI Consultants, Inc.  
570 Beatty Road  
Monroeville, Pennsylvania 15146

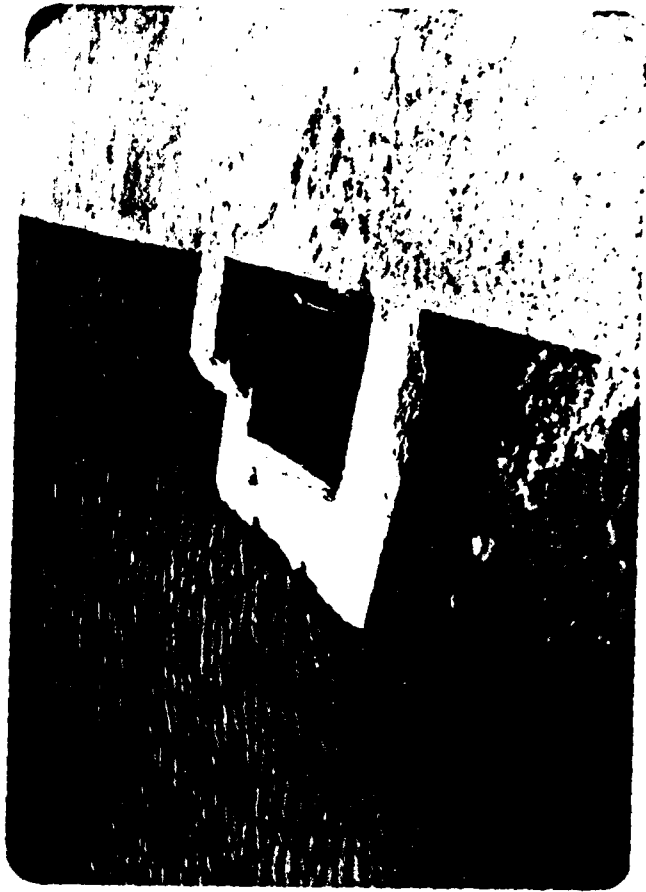
2. Outlet Conduit. The outlet conduit is reportedly functional and serves to supply water to the residents of Hawstone. The original gate tower along the upstream dam face is deteriorated and stripped of its inlet control mechanisms (see Photograph 8). Drawdown control was previously provided by a valve located at a "T" section about 80 feet downstream of the dam. The valve was removed in October 1979 and replaced with a standard elbow pipe section such that currently, no means of draining the reservoir is available.

PHOTOGRAPH 8 View of the deteriorated and dismantled gate tower that abuts the upstream dam face near the right abutment.
